On-Site Hog Farm Mortality and Birth-Related Tissue Composting Demonstration Project

General over view of the project

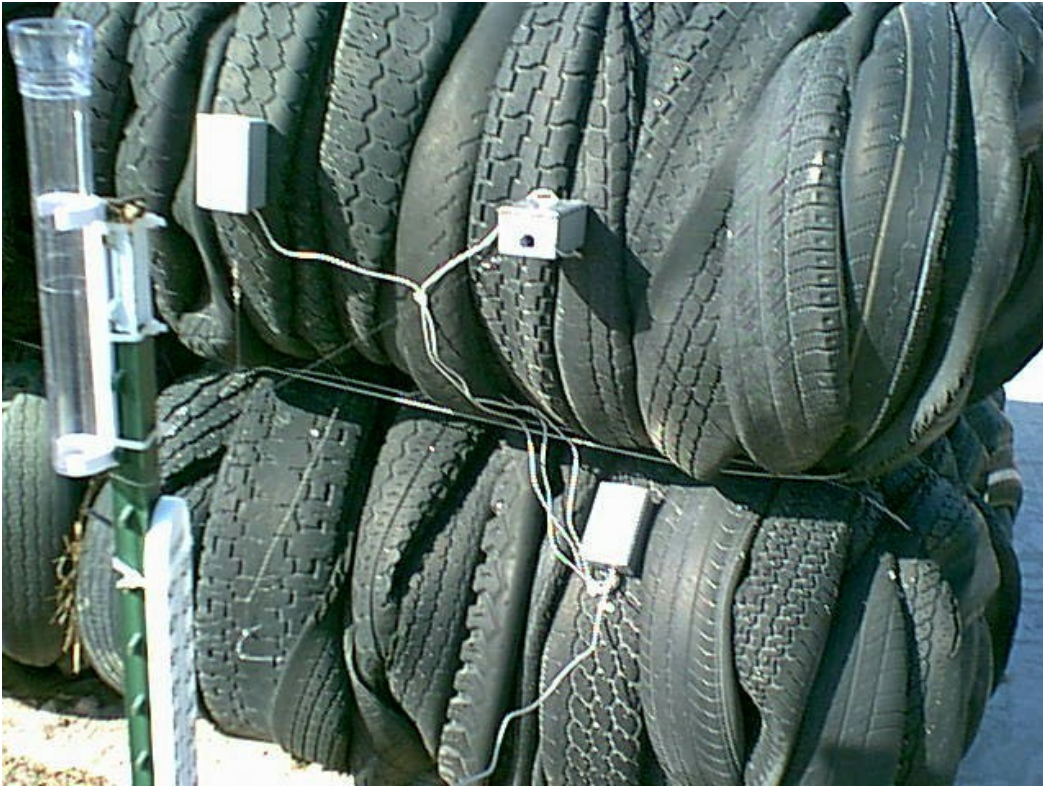
The straw bales also provided nesting areas for rodents. There is no evidence of rodents nesting in the tire bales during the demonstration project. The tire bales could last indefinitely. The weakest component of the bale is the baling wires. Bob Knecht, a professor with the Chemical Engineering and Petroleum Refining Department of Colorado School of Mines believes the baling wires could be cut on the lower bales without changing the structural soundness. It was believed that by cutting the wires the solar heat would encourage the bales to expand slightly and form a tighter seal to the outside. The Colorado School of Mines conducted their own activity of testing the structural soundness of the bales during this composting demonstration project. They collected data on 2 parameters – deflection and bale temperature. Preliminary data demonstrates that there is very little deflection. The tires move less than $\frac{1}{4}$ inch. The bale temperature tracked very closely with the outside temperature. The tires were consistently 30 degrees lower than the outside air temperature.

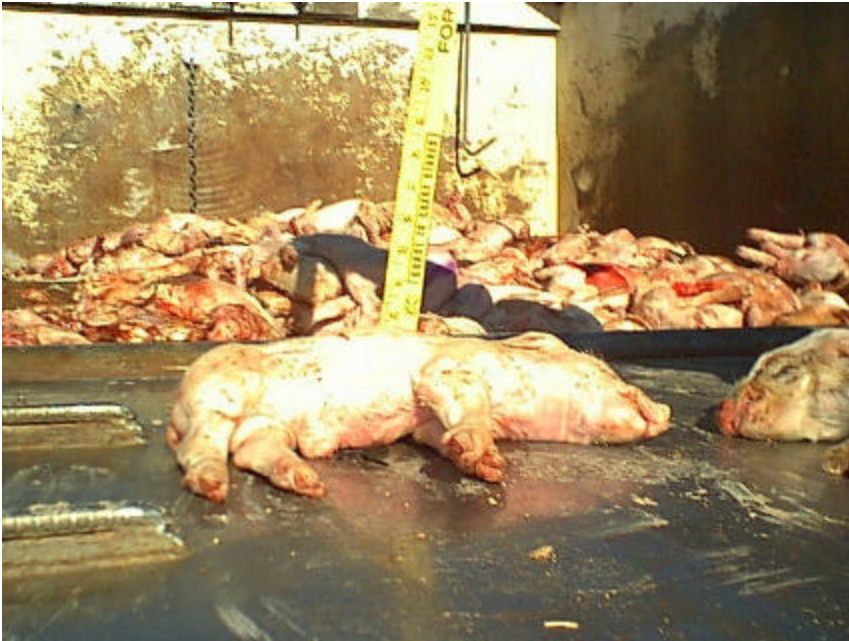
Site 1 began by using frozen "bucket" pigs. These are animals that are small enough to fit in a five-gallon bucket

The pigs were frozen because the process was to remove them from the barns late in the day and leave them outside for pickup in the morning. The overnight temperatures were in the teens to below zero for most of November and December. The frozen pigs prevented any decomposition to occur. Once this problem was identified the buckets were stored in the hall inside of the barns. This kept the pigs from freezing. Frozen carbon sources could also cause this problem & should be avoided.
